Manhole Inspection Summary

Manhole # S63A__008MH

Insp Date: **5/23/08 7:51 AM**

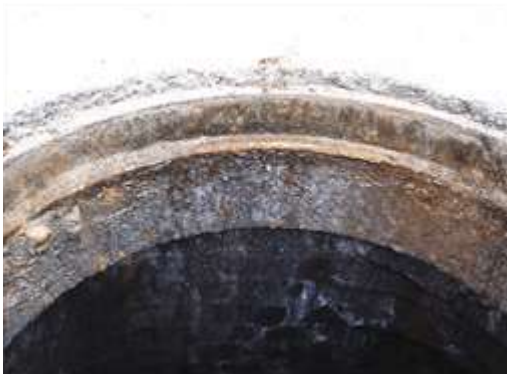
Defect 4

frame leaks

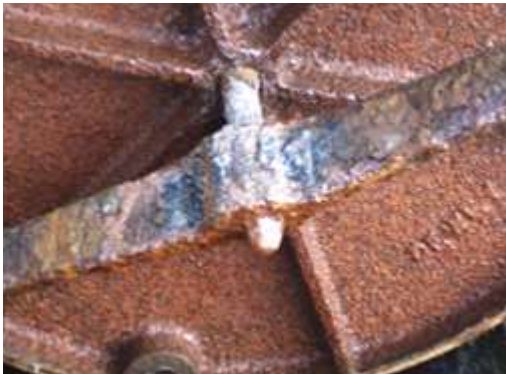
Defect 3

cover

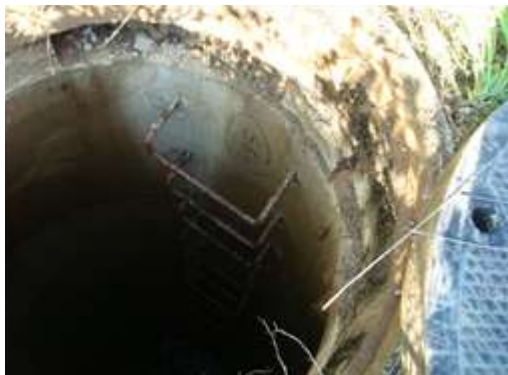
Defect 2

frame leaks

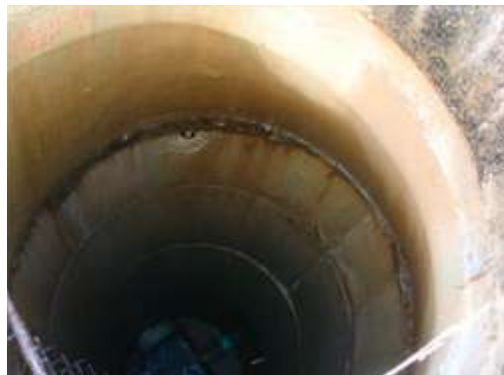
Defect 1

infiltration

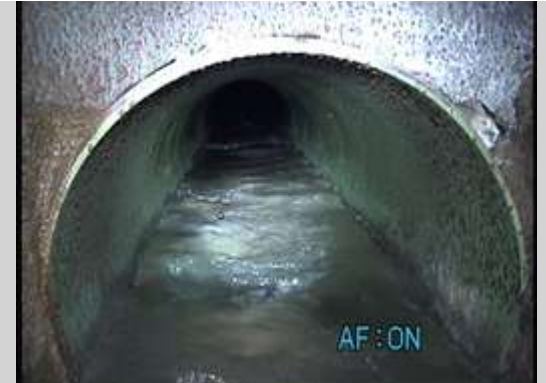
12 O'Clock Outflow

18 in. Circular Gravity Sewer
Pipe Out @ 12 O'Clock

Pipe Height: **18** (in.) Rod and Bar (Angled)
Pipe Material: **Concrete** ☐ Pipe Lined
Invert Depth: **20.10** (ft.) Flow Characteristics: **Fast**
Deposits: ☒ None ☐ Mud ☐ Sludge ☐ Debris ☐ Grease
Silt Depth: (in.) Deposits Extent:
Infiltration: **None** Pipe Seal Cond: **Sound**

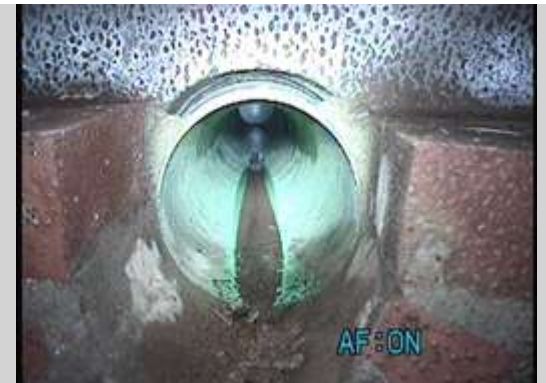
3 O'Clock Inflow

8 in. Circular Gravity Sewer
Pipe In @ 3 O'Clock

Pipe Height: **8.4** (in.) Rod and Bar (Angled)
Pipe Material: **PVC** ☐ Pipe Lined
Invert Depth: **19.15** (ft.) Flow Characteristics: **None**
Deposits: ☒ None ☐ Mud ☐ Sludge ☐ Debris ☐ Grease
Silt Depth: (in.) Deposits Extent:
Infiltration: **None** Pipe Seal Cond: **Sound**

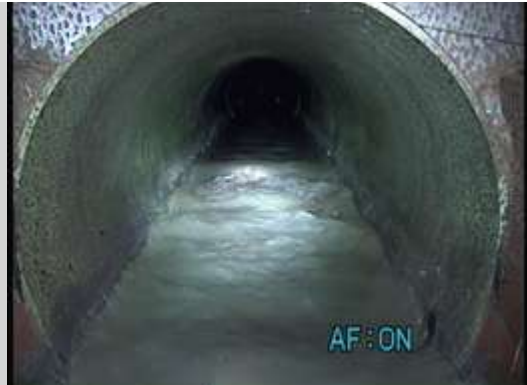
6 O'Clock Inflow

18 in. Circular Gravity Sewer

Pipe Height: **18** (in.) Rod and Bar (Angled)

Pipe Material: **Concrete** ☐ Pipe Lined

Invert Depth: **20.00** (ft.) Flow Characteristics: **Fast**

Infiltration: **None** Pipe Seal Cond: **Sound**
